GARNET LAKE DAM

**WARREN COUNTY, NEW YORK
INVENTORY NO. N.Y. 1167**

**PHASE I INSPECTION REPORT
NATIONAL DAM SAFETY PROGRAM**

AUGUST, 1981

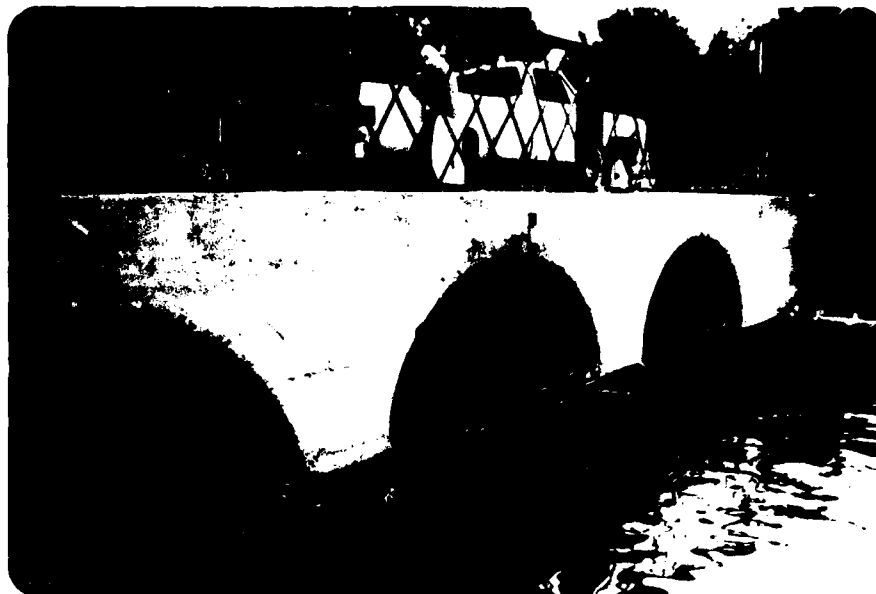
UPSTREAM HEADWALL TO PIPE-ARCHES;
NOTE CONTROL MECHANISM FOR RESERVOIR DRAIN

Present Condition (Describe): CONTROL MECHANISM ON UPSTREAM HEADWALL - IN FRONT OF MIDDLE PIPE - GATE HAS NOT BEEN OPENED IN 20 YEARS - PROBABLY INOPERABLE OUTLET COULD NOT BE LOCATED

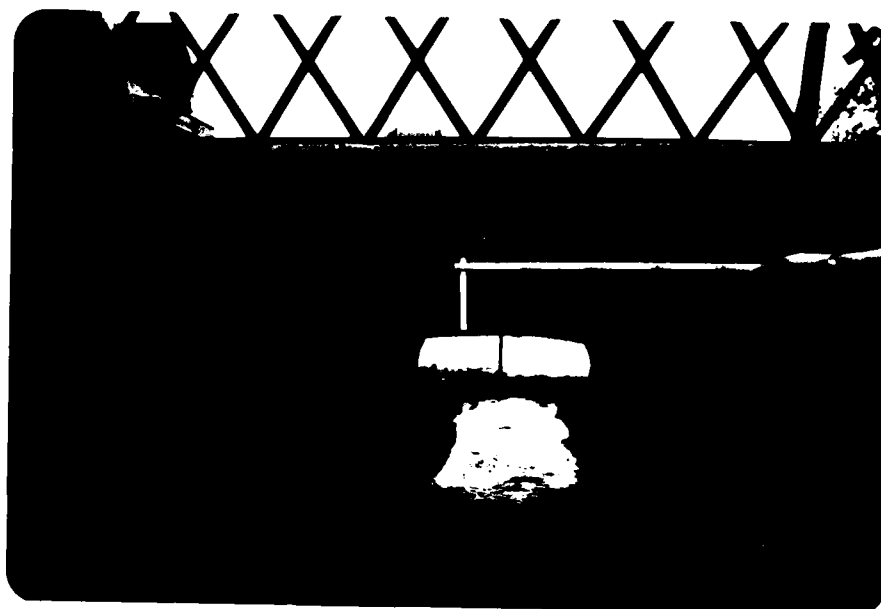
There were several deficiencies noted on the spillway section. There was a 3 inch gap between the crown of each of the pipe-arches and the downstream headwall. Several cracks and small voids were also noted on this headwall.

SEPARATION OF 3 INCHES BETWEEN
DOWNSTREAM HEADWALL AND CENTER PIPE ARCH

- d. The pool beyond the downstream toe of the dam should be drained and the soft area at the toe should be kept under surveillance.
- e. The gaps between the three pipe-arches and the downstream headwall should be filled.
- f. The cracks and small voids in the downstream headwall should be filled.
- g. The voids on the crest of the dam immediately above the spillway pipes should be filled.
- h. Voids under the downstream end of the concrete apron should be repaired.
- i. The reservoir drain should be made operational.
- j. An emergency action plan for the notification and evacuation of downstream resident should be developed.

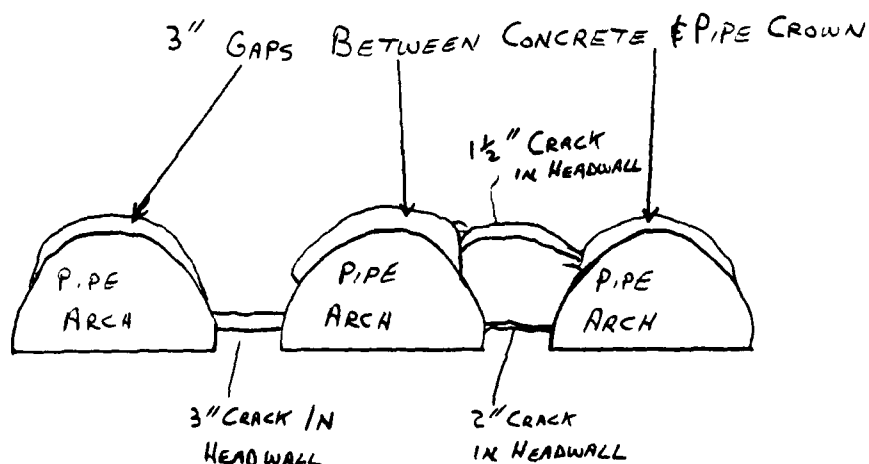
CONDITION OF DOWNSTREAM HEADWALL

- a. Concrete Surfaces SATISFACTORY- NO SPALLING OR SURFACE DETERIORATION NOTED
- b. Structural Cracking SERIOUS CRACKING ON DOWNSTREAM HEADWALL CRACKS OF UP TO 3" IN WIDTH NOTED (SEE DIAGRAM BELOW)
- c. Movement - Horizontal & Vertical Alignment (Settlement) MOVEMENT OF DOWNSTREAM HEADWALL HAS RESULTED IN 3" GAPS BETWEEN PIPE CROWN & THE WALL
- d. Junctions with Abutments or Embankments 1" CRACKS NOTED BETWEEN DOWNSTREAM APRON & SIDEWALLS - SOME LOSS OF CONCRETE IN THIS AREA
